An original Approach to Retrofitting A Post and Core Restoration to an Existing bridge

Citation: Debbabi Imen, Saafi Jilani, Nouria Zohra, Harzallah Belhassen, Cherif Mounir (2018) An original Approach to Retrofitting- A Post and Core Restoration to an Existing bridge. J Oral Health Dent Sci 2: 202

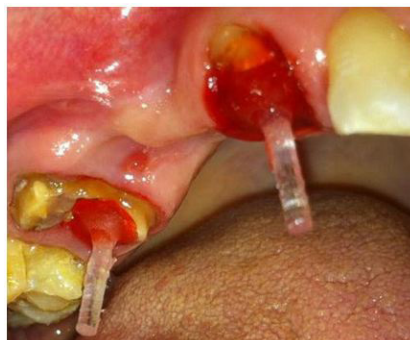
Figure 7: The plastic posts were rebazed with duralay resin

The healing of the gum related to the socket was well improved. After selecting an appropriate size of plastic posts (Para-Post, Whaledent International, New York, N.Y.), they were inserted into the prepared root canals. The plastic posts were rebazed by coating the post with an autopolymerizing acrylic resin material (Duralay, Reliance Dental Mfg Co, Alsip, Ill.) to ensure better adaptation to the teeth structure (post in post space of #13 and the palatal post space of the #16) (Figure 7). The length of the post were adjusted by cutting them with a disk so they do not interfere with the inner surfaces of the retainers which can jeopardize accurate seating and appropriate occlusion (Figure 8).

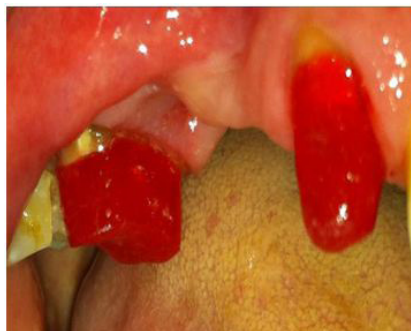
Figure 11: Models of 2 casted post and core after refining

The refabricated Duralay posts and cores were checked so that there was no deficiency of the material and that the contour of the previous cast post and core was reproduced and excessive core material may remain over the margin was removed using a probe. The setting time of the Duralay resin is 5 min. the models of 2 posts and cores were refined using dental diamond bur on turbine under irrigation to create additional cement space between the abutments and the retainers, then sent to the laboratory to be casted in metal (Figure 11,12 and 13) [5]. Obviously at this step adding grooves or boxes to the refabricated duralay post and core (new abutments) limits the paths of placement, so retention is increased [9].

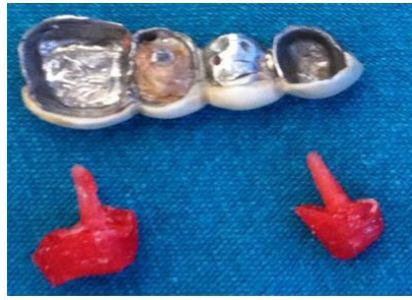
Figure 12: Old bridge with two models of two duralay posts and cores

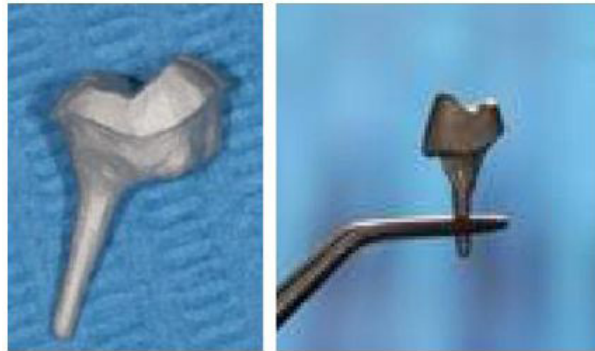
Figure 13: The models of 2 posts and cores casted in metal

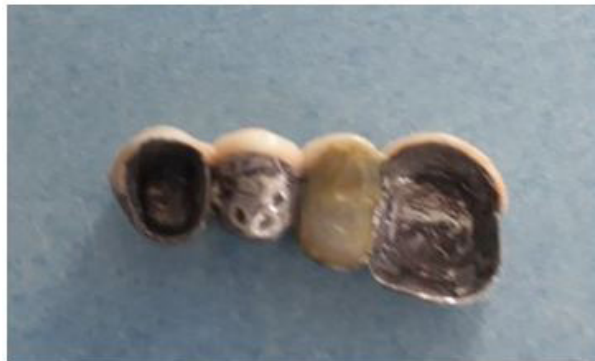
Figure 14: Light cure composite resin filled in the inner surface of tooth #15

In the lab, the fitting surface of retainer on # 15, already extracted, was cleaned and most effectively prepared by air-abrading with 50mm of alumina and in the clinic it was filled with a light cure composite resin to be transformed into Pontic (Figure 14).

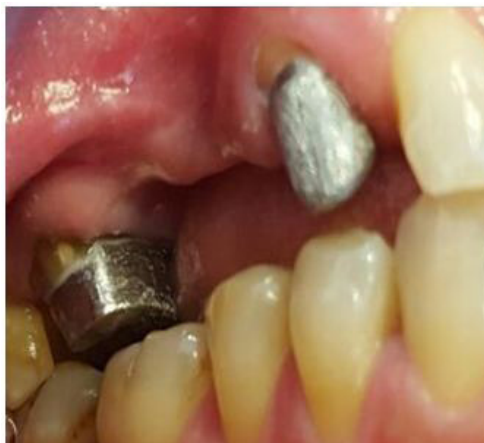
Figure 15: The 2 casted post and core are cemented

The casted posts and cores were tried in the mouth without the bridge to ensure their perfect adaptation, then in a second time with the bridge in situ to assess the absence of over-occlusion. Finally, they were cemented with adhesive glass ionomere cement (Figure 15). In the last time, the bridge is cemented using zinc phosphate cement (Figure 16).
