# Esthetic Restoration of Two Severely Decayed Maxillary Central Incisors: A Case Report

In this article, a 25-year female patient was referred to our department of fixed prosthodontics for an esthetically compromised smile due to severely decayed central incisors and she requested esthetic smile rehabilitation. The two incisors were restored with fiber post composite and CAD/CAM zirconia based ceramic crowns as extra-coronal restoration.

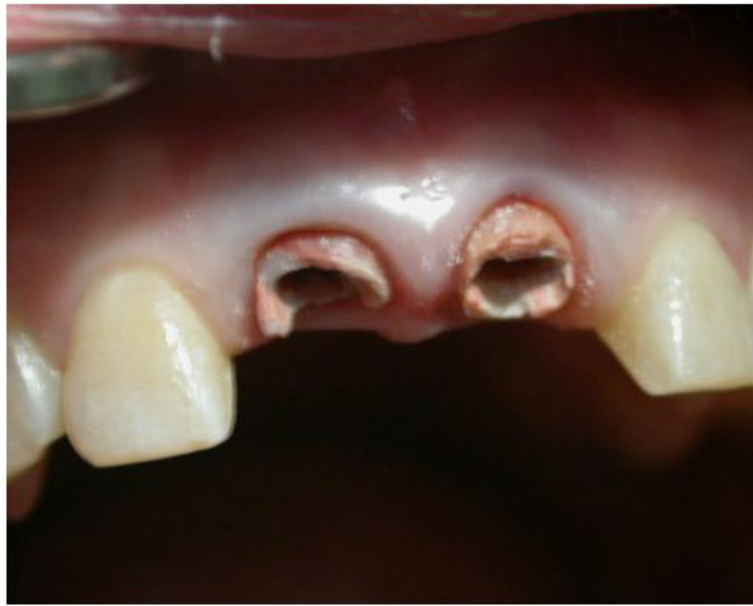
Intra-oral examination showed an average lip line exposing the maxillary teeth and only the interdental papillae as well as severe cervical decay with significant substance loss. The anterior guide is non functional with posterior interferences (Figure 1).

**Figure 1:** Intra-oral view

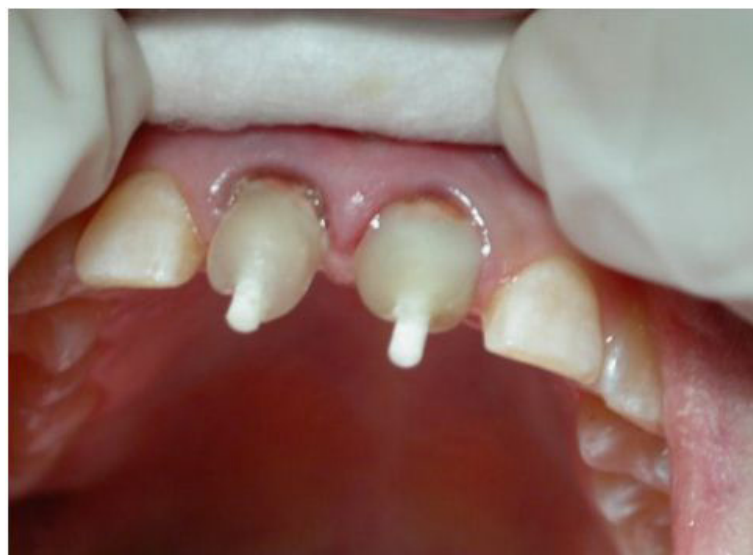
The preparation was achieved with using flat end tapered diamond bur and extended in the sulcus to cover all the discolored abutments (Figure 2).

**Figure 2:** Build-up technique by fiber reinforced posts composite resin

The central incisors have been restored by build-up technique with two fiber reinforced posts composite resin.

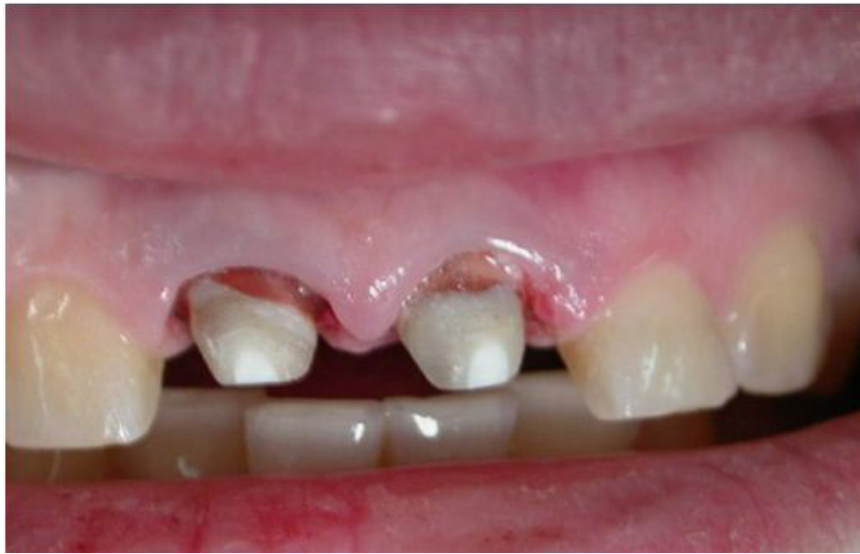
The internal aspect of the margin should be either a rounded shoulder or a deep chamfer of at least 1 mm [9]. A 90° internal angle is contraindicated. The exit angle of the gingival margin should be a butt joint and lack any beveled edges (Figure 3 and 4).

Figure 3: Final preparations

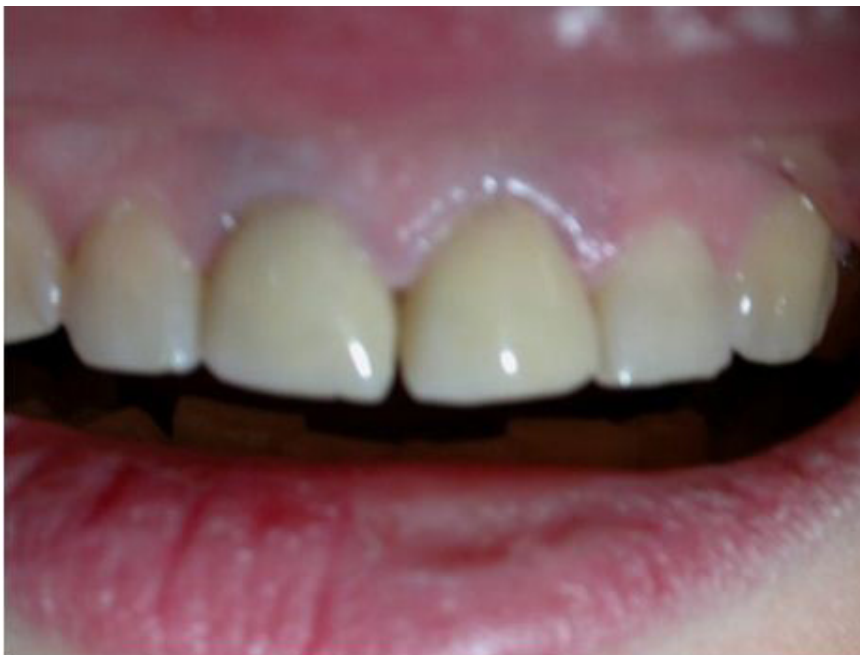
Figure 4: Temporary Prostheses

The temporary prosthesis was made in the laboratory by a resin with high aesthetic and mechanical properties. The sealing was carrying out by free eugenol cement. After an aesthetic evaluation (color, shape, size and position of teeth) and functional checking (anterior guidance, phonation), a final impression was taken using polyvinyl siloxane and sent to the laboratory. The shade selection was taken with shade guide Vitapan 3D Master-Vita. There the working cast was scanned and frameworks were manufactured with computer-aided manufacturing after the step of computer-assisted design using CAD/CAM indirect technique.

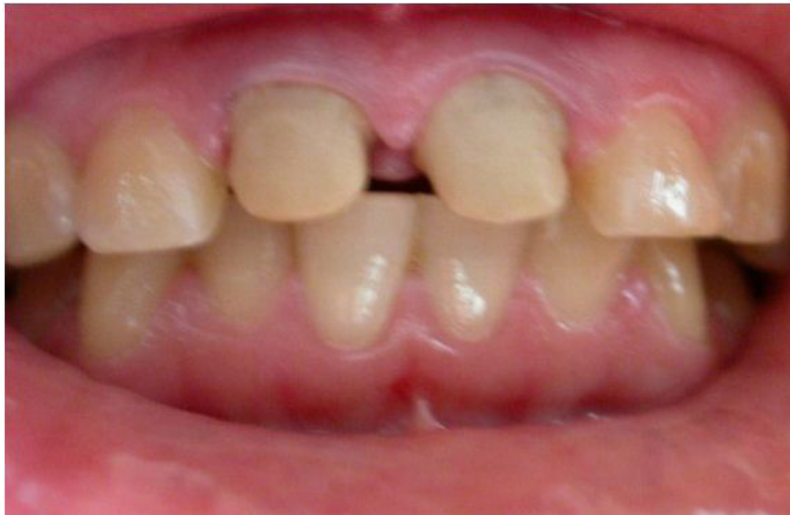
Fabricating zirconia single copings and frameworks involves the manipulation of a 3-D design on the computer screen, followed by the automated production by a computer-controlled milling machine [10]. There are three components to the CAD/CAM system: scanning, designing, and milling. All are usually housed at the laboratory (Figure 5).

Figure 5: Trying zirconia frameworks

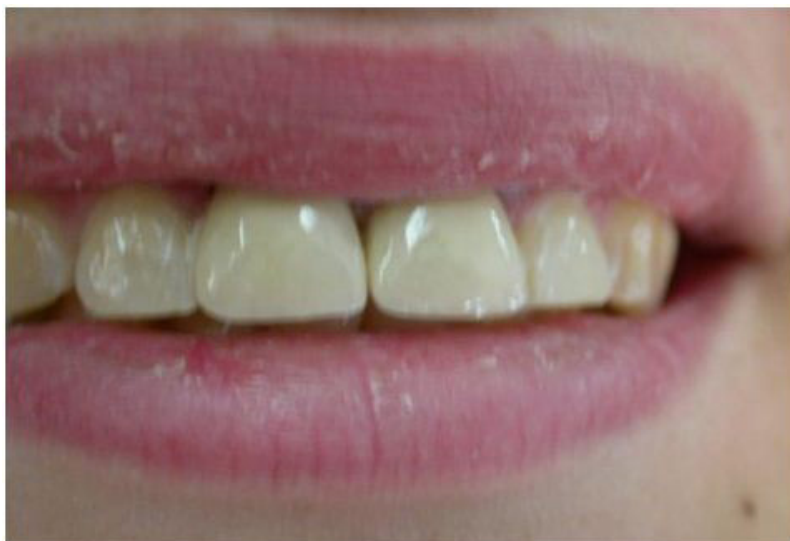
Every zirconia framework always requires a try-in step to confirm fit, insertion retention, marginal integrity, and mostly the space left for cosmetic ceramic without omission of the shade appearance. Then, ceramic stratification was performed in the lab [11] (Figure 6).

Figure 6: Extra-oral view after cementation with adhesive cement

In the clinic, zirconia ceramic crowns were tried again to verify esthetic, occlusion relationship and cemented using adhesive cement.
